**Determination: Soil sampling, USTs****PA/VSI Or RFA FILE REVIEW CHECKLIST**

Facility Name: Kvaerner Songer (Penmark Associates, Ltd.)

EPA ID: MID 005 341 979\_\_\_\_ City: 2219 Chapin Jackson, Jackson Co.\_\_\_\_ State: MI\_\_

**Technical Enforcement Support  
at Hazardous Waste Sites  
Zone III  
Regions 5,6, and 7**

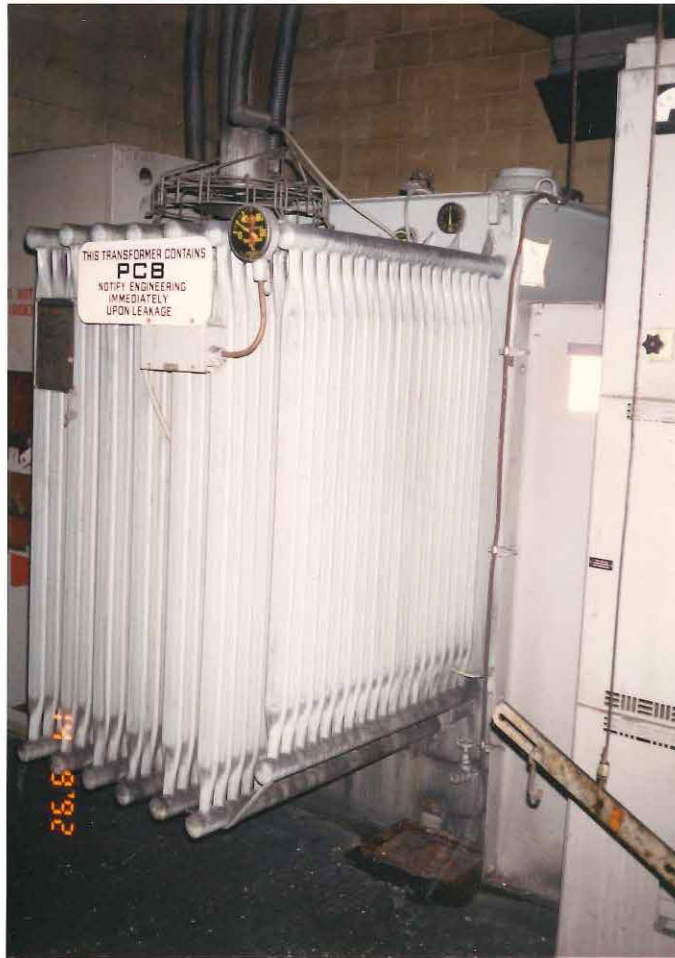
Photograph No. 10  
 Orientation: West  
 Description: This photograph shows Transformer No. 9.

Location: AOC 2  
 Date: September 14, 1992

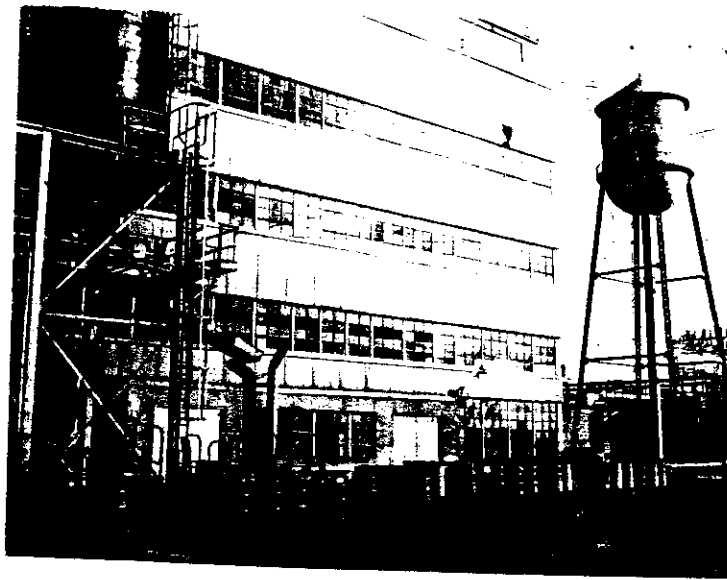
**ATTACHMENT D**  
**PART A PERMIT APPLICATION PHOTOGRAPH**

- Drum Storage Area
